Contract #: 04-0120F4Cty: SF/ALA Rte: 80 PM: 13.2/13.9File #: 69.28**WELDING INSPECTION REPORT****Resident Engineer:**Siegenthaler, Peter**Address:** 333 Burma Road**City:** Oakland, CA 94607**Report No:** WIR-023979**Date Inspected:** 29-Apr-2011**Project Name:** SAS Superstructure**OSM Arrival Time:** 700**Prime Contractor:** American Bridge/Fluor Enterprises, a JV**OSM Departure Time:** 1900**Contractor:** Zhenhua Port Machinery Company, Ltd (ZPMC), Changxing Island **Location:** Shanghai, China**CWI Name:** Geng Wei**CWI Present:** Yes No**Inspected CWI report:** Yes No N/A**Rod Oven in Use:** Yes No N/A**Electrode to specification:** Yes No N/A**Weld Procedures Followed:** Yes No N/A**Qualified Welders:** Yes No N/A**Verified Joint Fit-up:** Yes No N/A**Approved Drawings:** Yes No N/A**Approved WPS:** Yes No N/A**Delayed / Cancelled:** Yes No N/A**Bridge No:** 34-0006**Component:** OBG Components**Summary of Items Observed:**

Outside Yard – OBG Trial Assembly

WELDING INSPECTION REPORT

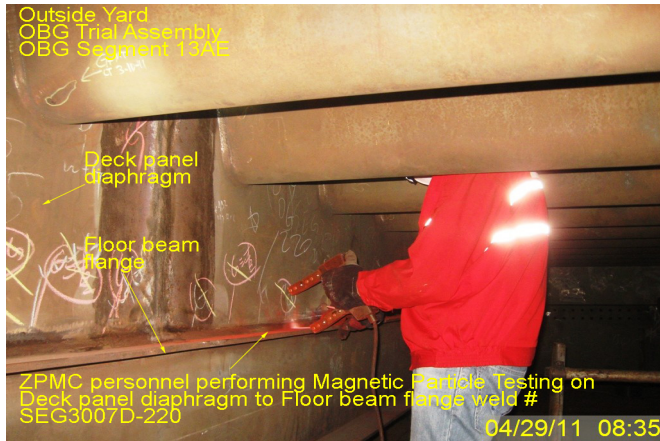
This QA Inspector observed ZPMC qualified NDT personnel perform Magnetic Particle Testing on Deck panel diaphragm to Floor beam flange weld at Panel Point 119.65 of OBG Segment 13AE. Weld joint is identified as SEG3007D-220. See attached picture.
